QUAD

**electrostatic
loudspeaker
service supplement**

SERVICING QUAD ELECTROSTATIC LOUDSPEAKERS

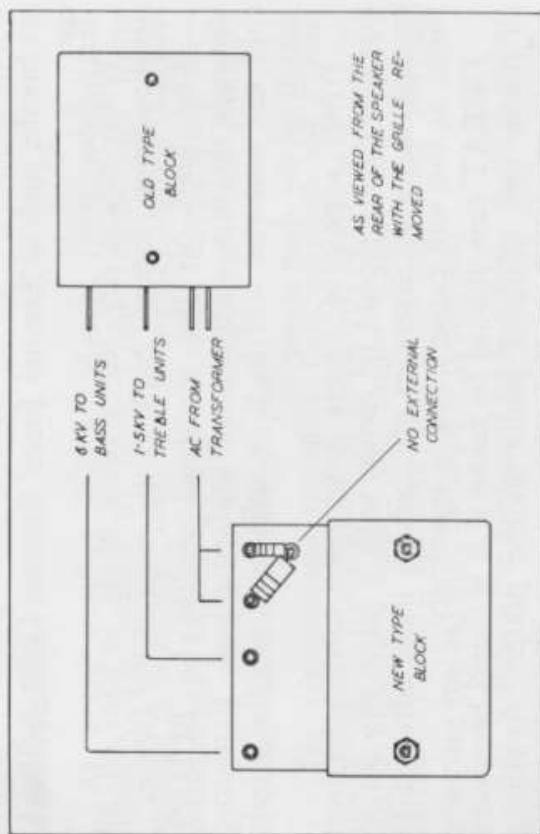
To replace the rectifier block of the EHT unit, undo the two 4BA nuts securing it to the framework of the EHT unit and remove it. If the replacement block is found to be of a different type it will still be electrically and physically interchangeable with the earlier type, and the equivalent connections are shown in Fig. 1. If the leads to the loudspeaker units have to be extended, the joints should be insulated with high voltage sleeving and staggered so that two joints do not lie together.

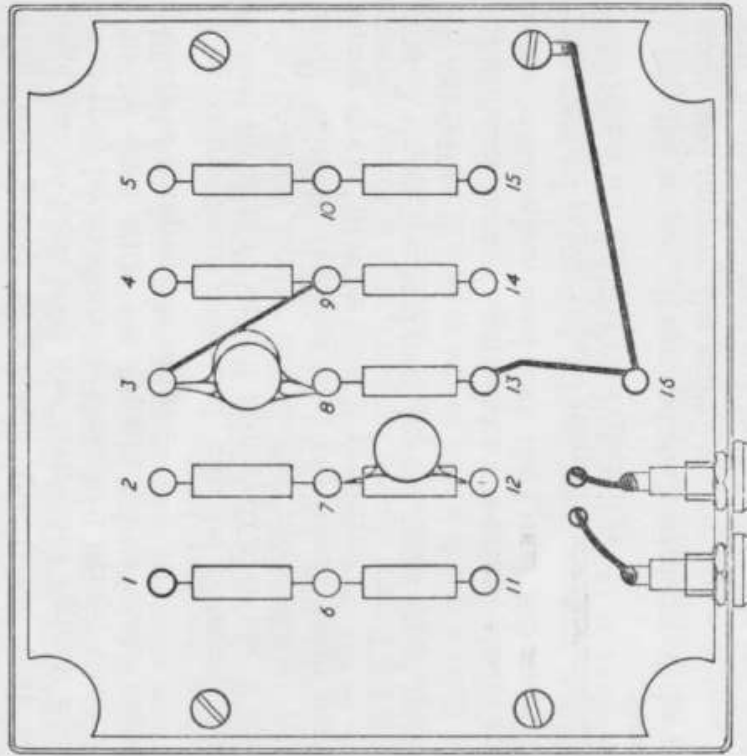
Fig. 3 shows the tagboard layout from serial number 16800 onwards.

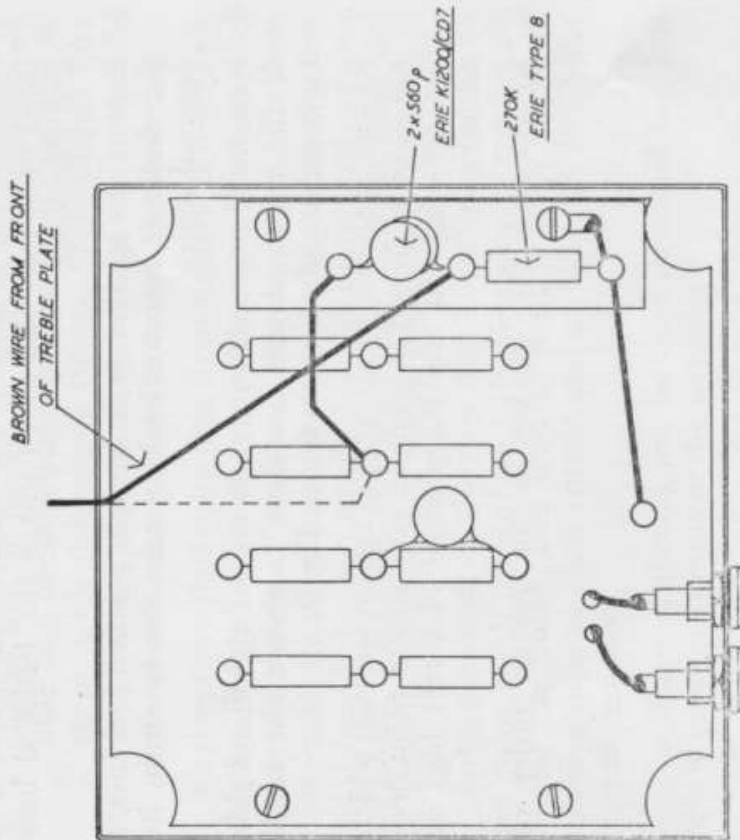
The components required can be obtained ready assembled on a tagboard, if required, and Fig. 2 shows this in position under the audio transformer. Alternatively, suitable resistors and capacitors from normal servicing stocks, may be used if preferred.

4. Remove the four screws holding the audio transformer (large can on the lefthand side) in place, remembering to support the transformer before it is freed or it may slip and damage the lefthand bass unit dustcover.
5. Restore the speaker to an upright position and invert the audio transformer, taking care not to strain its external wiring.
6. Remove the two drive screws on the righthand side of the tagboard and use these to secure the small tagboard supplied, as shown in Fig. 2.
7. Rewire as shown, ensuring that the brown lead which has to be stretched to reach its new anchor point does not press against any sharp edges of turret lugs or solder.
8. Re-assemble the speaker in the reverse order of operations 1 to 5.

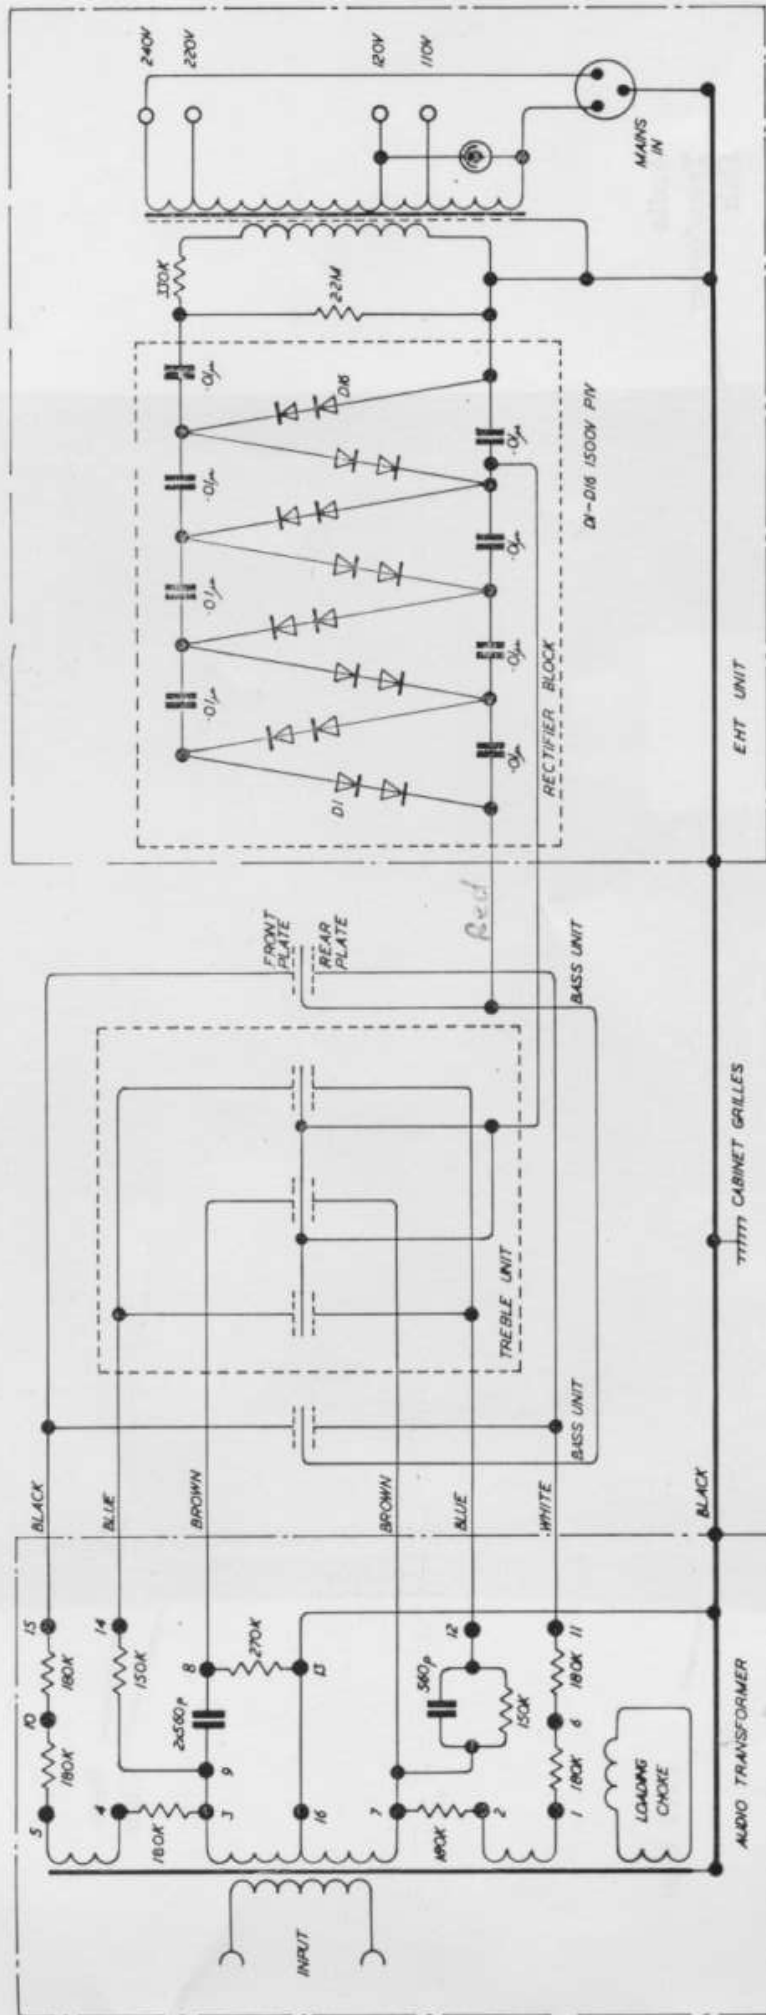
Fig. 3.

**Treble
Unit**

**Bass
Units**

**Audio
Transformer
Unit**

EHT Unit
